Kielland:

What happened?
- theories on causes

Kian Reme, Kielland Network

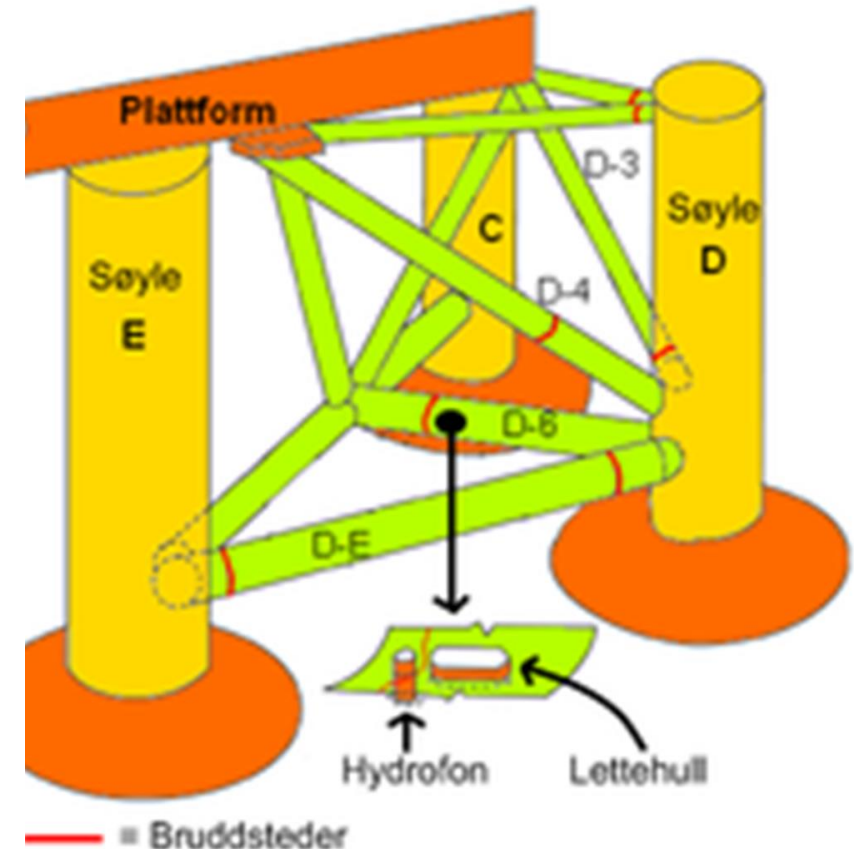
One triggering cause:

Fatigue fracture by the hydrophone in D6 brace.

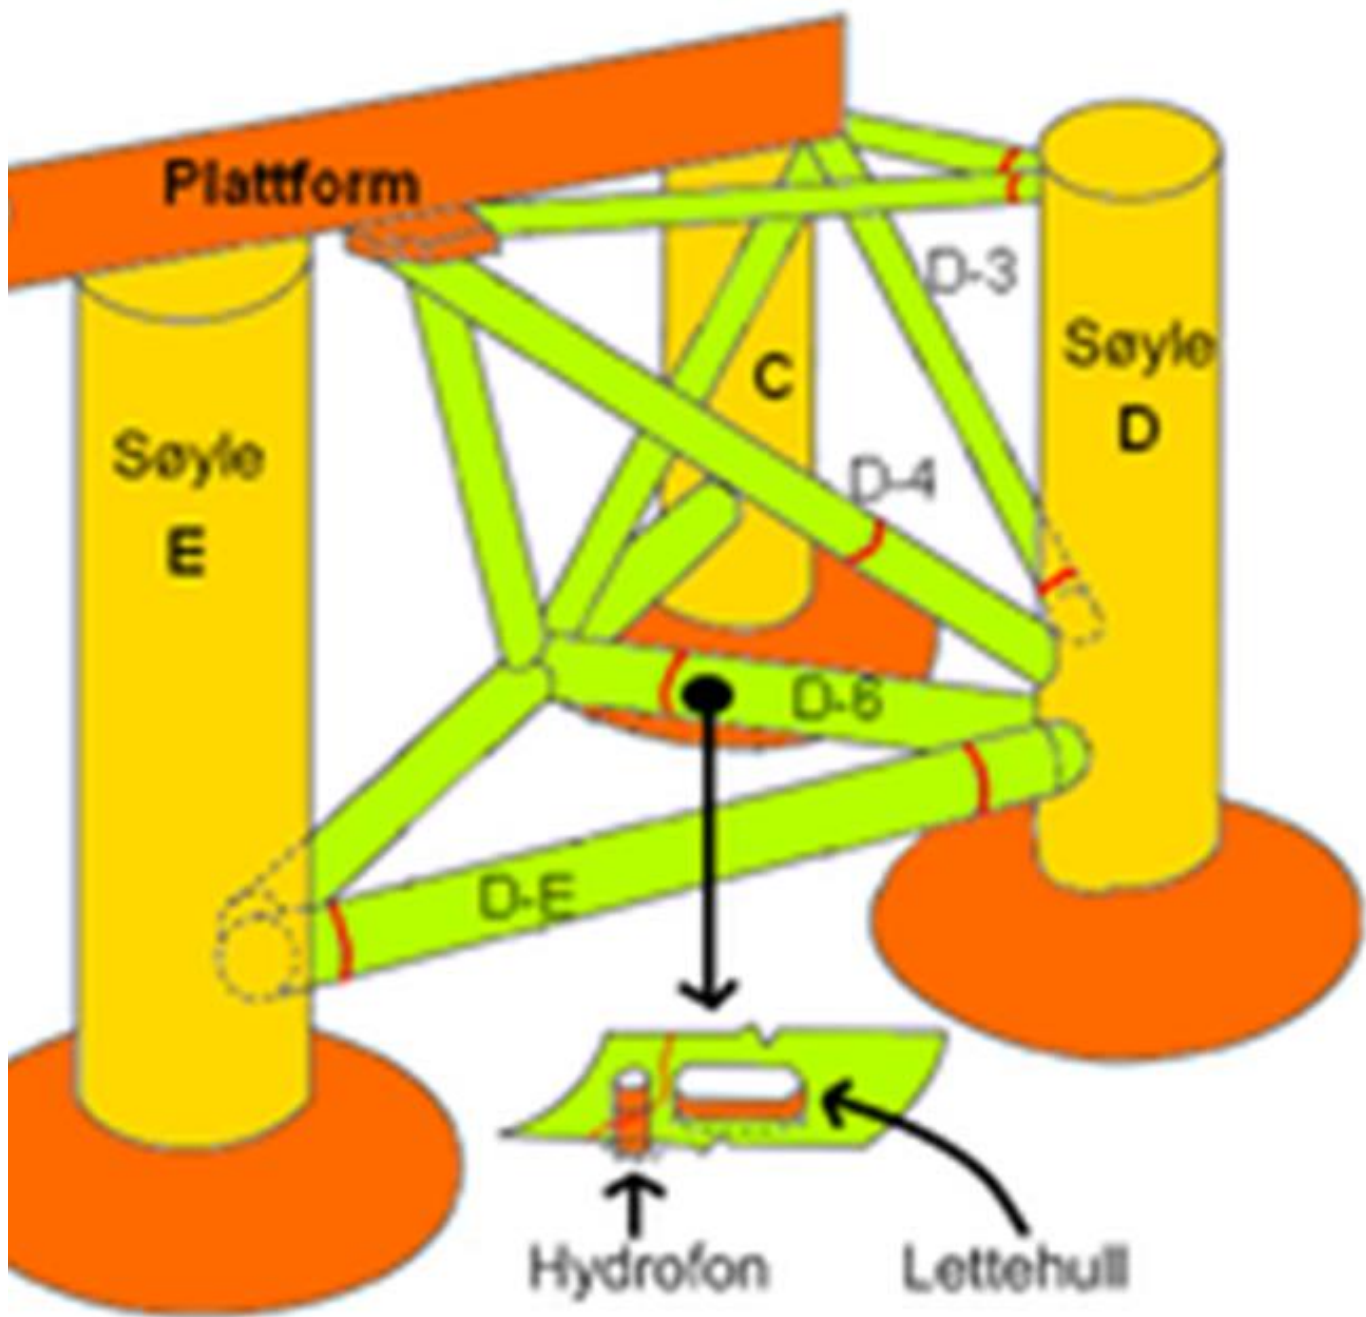
— ■ Bruddsteder

Explosion in D4 brace

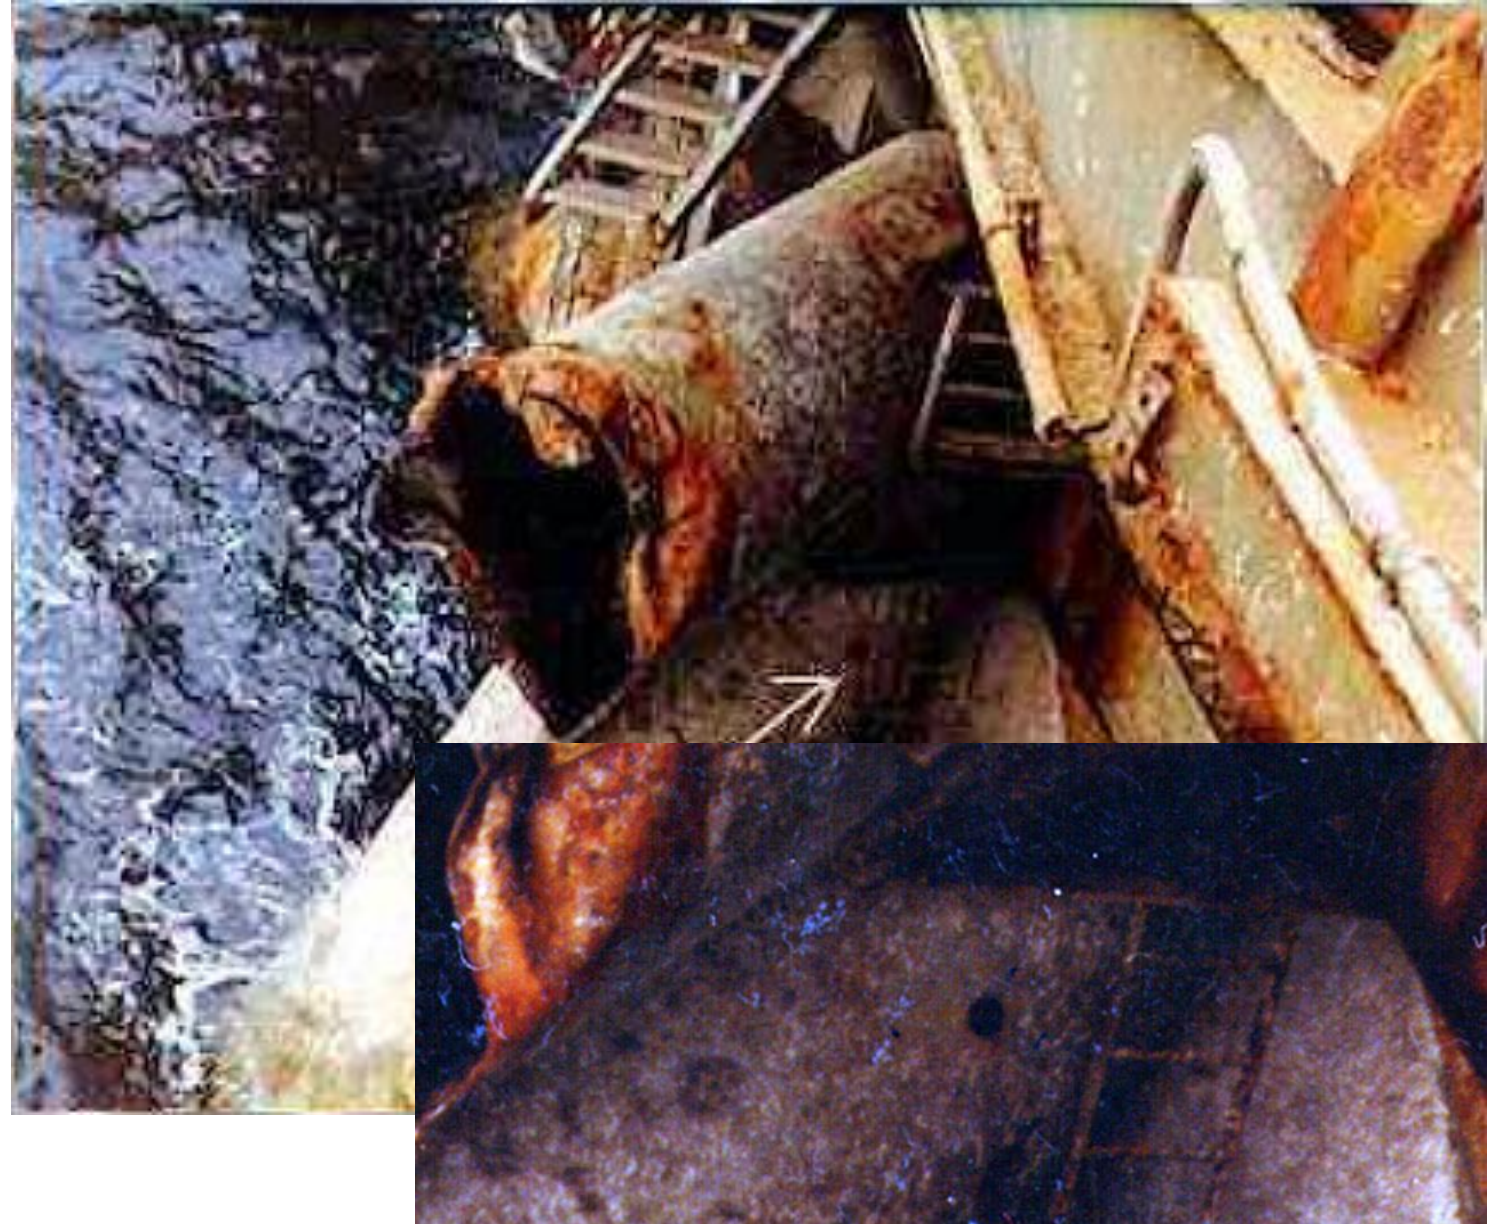
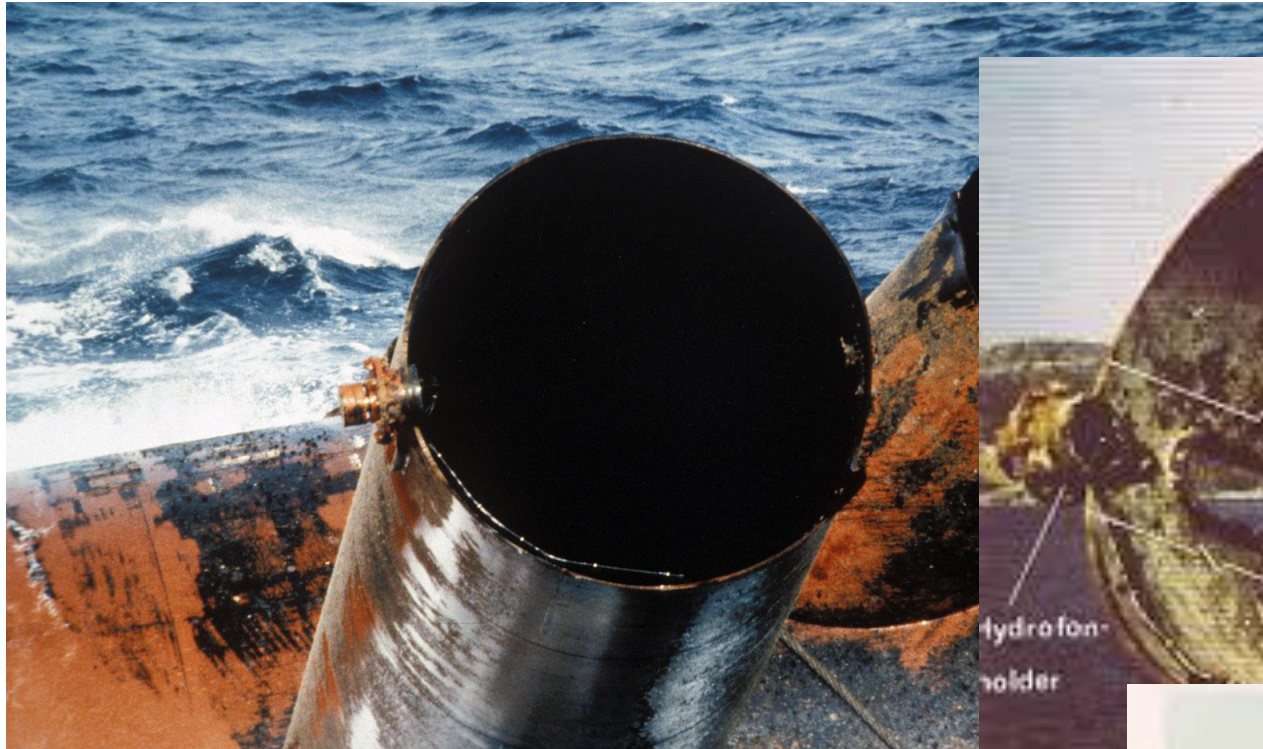
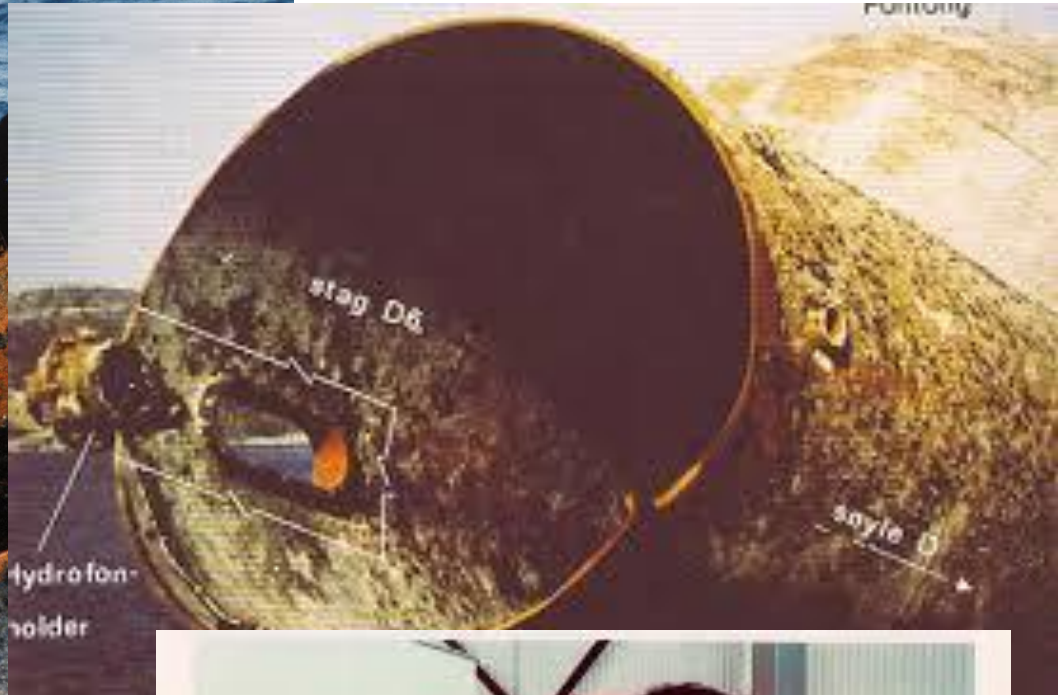
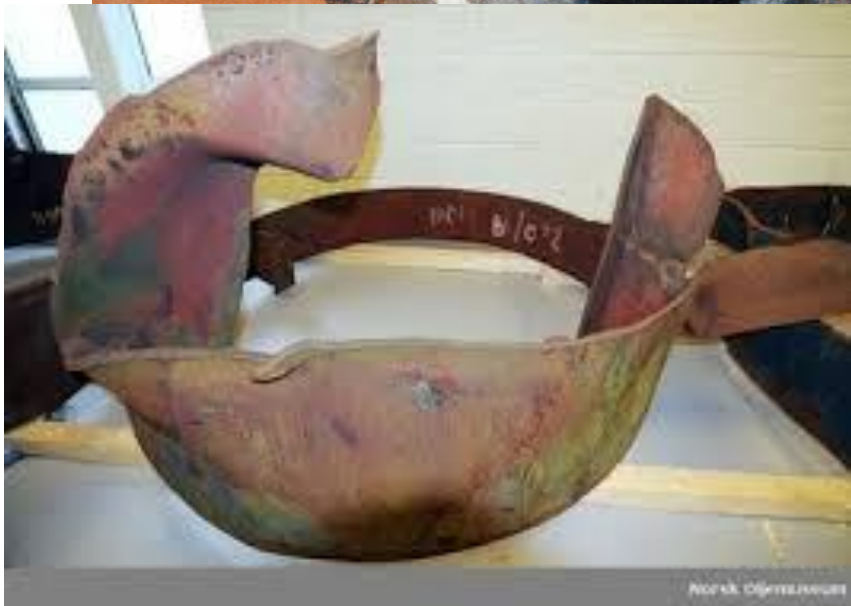
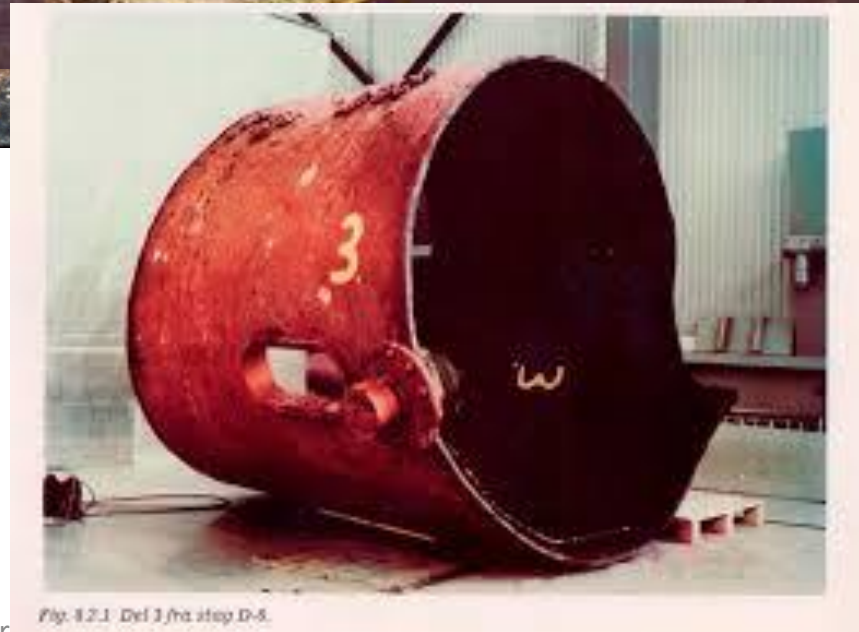
Indications

- Hole in D4 brace
- Photos of the braces
- Missing material in D6
- Explosion experts
- Metallurgy tests
 - Bainite and twins
